Thermographic Study on Thermal Performance of Rural Houses in Southwest China

ABSTRACT

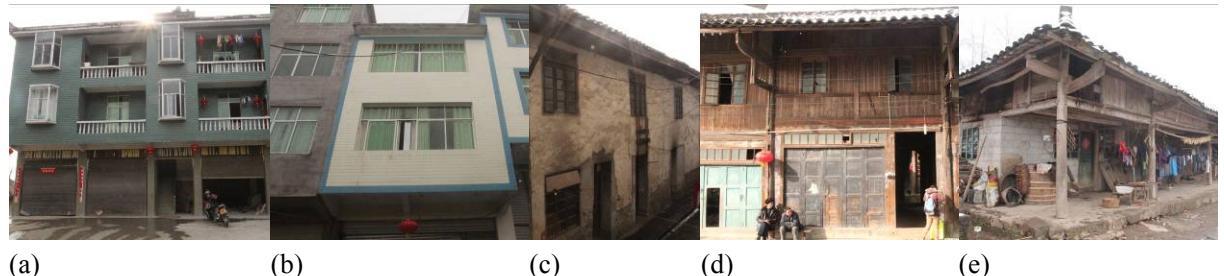
Figure 1 Five typical rural houses of different envelopes (a) and (b) Cement brick with ceramic tiles; (c)Stone; (d) Wood; (e) Partly wood and partly cement brick

The five representative rural houses we chose to take thermographs include two modern ones (built after 1990s) and three traditional ones (built before 1980s), as shown in Figure 1. House (a) and house (b) are three-storey reinforced concrete frame structures, infilled with 390mm x 390mm x190mm cement bricks. The exterior walls are 400mm thick approximately, covered with glaze ceramic tiles. The exterior windows are single-glazed aluminum alloy windows. The ground floors used as garage or store enclosed with metal shutter doors. House (c) was two-storey stone structure built in the 1950s, as the dormitory for slaughterhouse workers. The exterior walls are 500mm-600mm thick with lime plaster layers. The exterior windows and doors are single-glazed framed with wood. House (d) and house (e) are timberwork houses represent the most common vernacular architectural styles in the Southwest China. The exterior windows and doors are same as house (c). The exterior walls are 20-30mm thick wooden boards. House (d) was built in the1930s and house (e) was built in 1961. Some alterations have been made for house (e) and the exterior walls are partly replaced by exposed cement bricks. None of these exterior walls or roofs has thermal insulation layers.

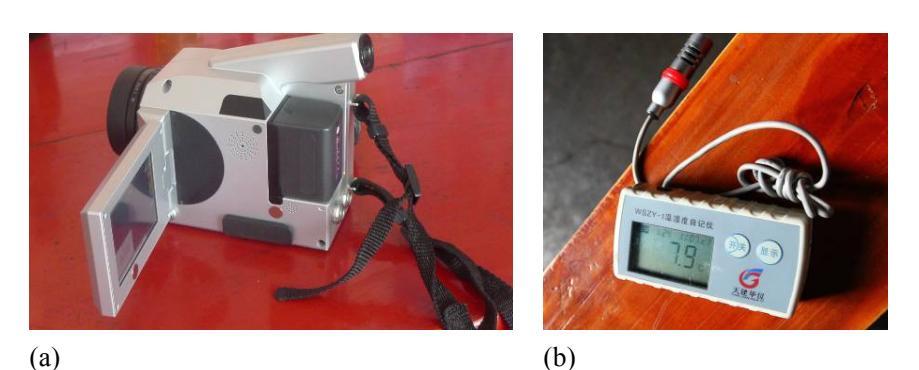
Figure 2 The instruments for measurements. (a) is infrared thermographic camera and (b) is hygrothermograph meter

Table 1. Detailed Information of the Instruments							
Physical quantity	Instrument	Range	Accuracy				
Surface temperature	VarioCAM HR Inspect	7.5µm~14µm	0.05°C				
Air temperature	WSZY-1	-40°C ~100°C	0.1°C

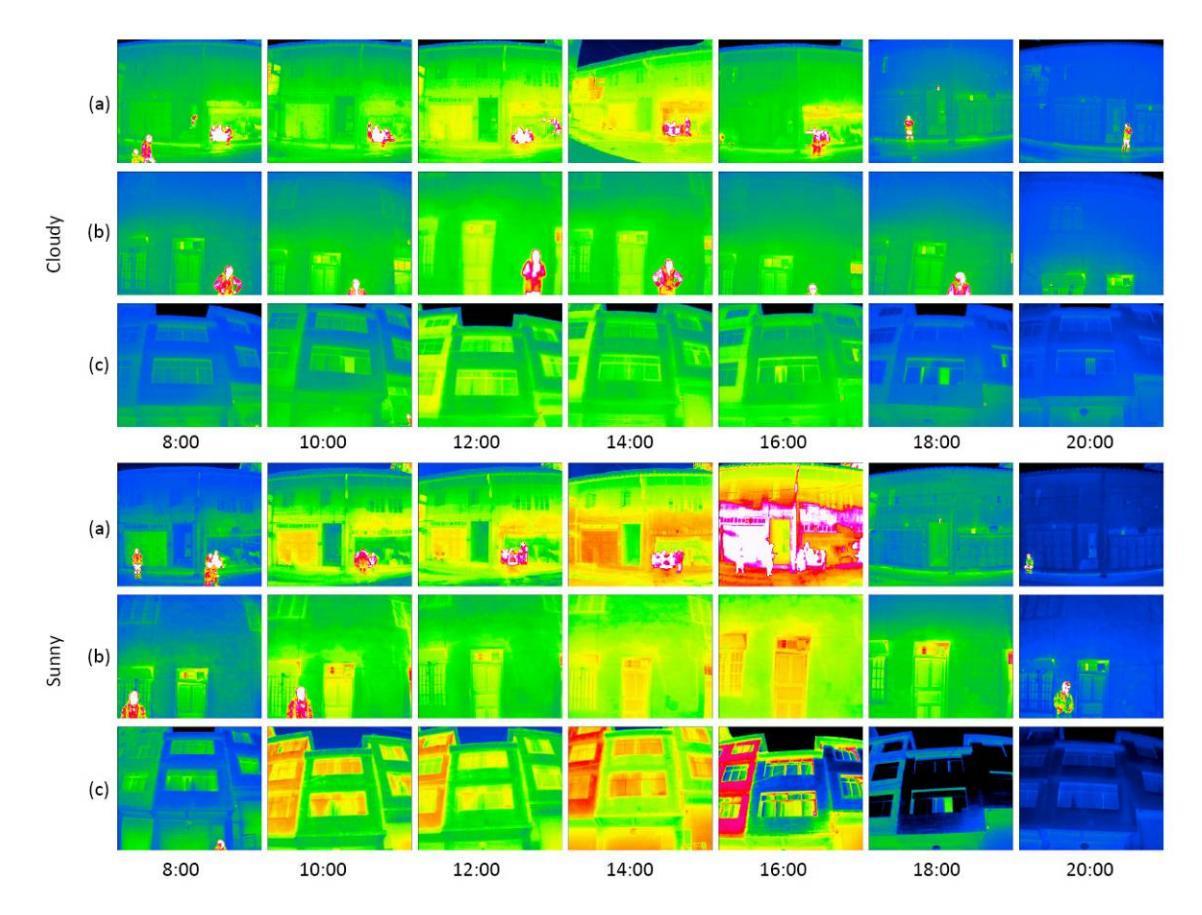
Figure 3 Thermographs taken on February 16th (cloudy day) and 20th (sunny day), 2014. (a) is wooden board wall; (b) is stone wall with lime plaster; (c) are cement brick walls with glaze ceramic tiles (in the middle) and cement plaster (on the left).

Figure 3 shows a series of thermographs illustrating thermal processes of four different building envelopes in winter affected by the parameters mentioned above. During the period of the measurements, the sunrise time is 7:20 am and sunset time is 6:40 pm. The outdoor air temperatures range from -2.3°C to 2.0°C on cloudy day and -2.1°C to 5.2°C on sunny day. The average outdoor air temperatures are 0.02°C and 1.17°C respectively. The average surface temperatures of different building envelopes were measured through these thermographs, **as shown in Figure 4**. It's important to note that

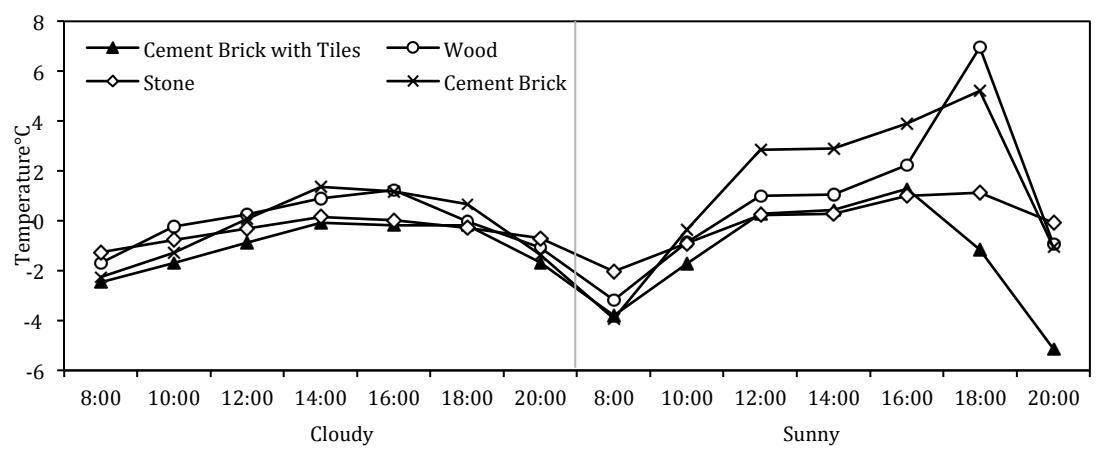
Figure 4 Average surface temperatures of different building envelopes

only opaque surfaces were taken into account for calculating the average temperature. That's because it is hard to obtain accurate temperature of glazing unit due to the influence of reflection. Besides, the glaze ceramic tiles can also reflect sky and buildings around it which may lead to errors on the thermographs. Figure 4 can give us a direct impression that there are great differences in the average exterior surface temperature between different envelopes on sunny day, but little differences on cloudy day. On cloudy day, wooden envelope has the highest average surface temperature of -0.9°C, with the maximum value of 1.24°C. While on sunny day, the temperature of cement brick wall with mortar plastering is the highest, the average value is 1.36°C and the maximum value is 5.21°C. In contrast, the surface temperature of cement brick wall with glaze ceramic tiles is the lowest on both cloudy and sunny days because its light-colored and polished surface has high reflectivity. The average values are -1.02°C and -1.4°C respectively. The surface temperature of wooden and mortar plastering envelopes fluctuate strongly, with the values of 2.93°C and 3.63°C on cloudy day and 10.14°C and 9.14°C on sunny day, respectively. The amplitude of temperature fluctuation of the stone wall is the smallest due to large thermal mass and thermal resistance. On cloudy day, the highest exterior surface temperature is reached around 2:00 pm, while it peaks at 6:00 pm on sunny day except for tiled brick walls. The accumulation of solar radiation is one reason for the difference. Another significant factor is the northwest orientation led the envelope to a western exposure before sunset.

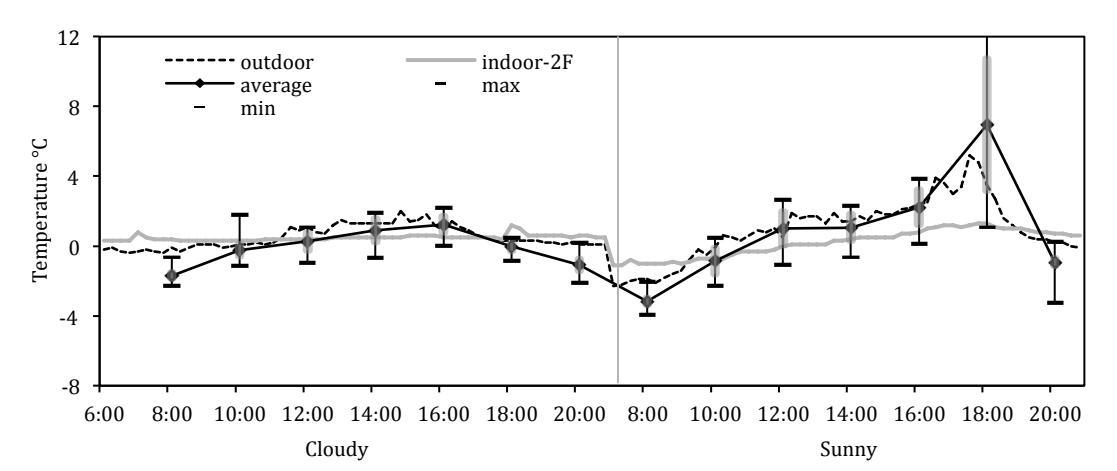
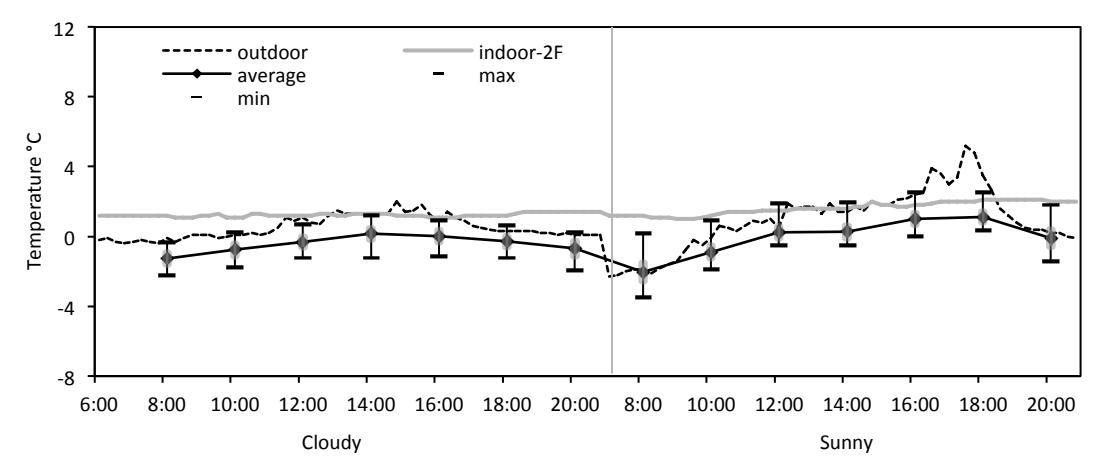
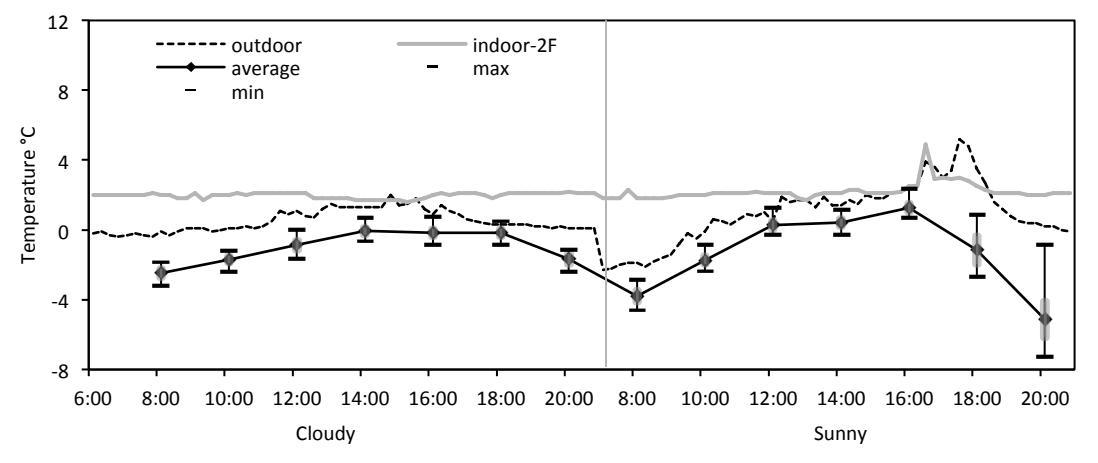
Figure 5 Surface temperature distribution and indoor/outdoor air temperature of building with wooden walls

Figure 6 Surface temperature distribution and indoor/outdoor air temperature of building with stone walls

Figure 7 *Surface temperature distribution and indoor/outdoor air temperature of building with tiled cement brick walls*

Figure 5 to Figure7 shows the comparison of exterior surface temperature and outdoor/indoor air temperatures of these buildings. It is obvious that the fluctuation of exterior surface temperature is consistent with the outdoor air temperature. No heating equipment has been adopted in the rooms we measured which are adjacent to the envelopes. The interior air temperatures of these rooms are more stable and relatively low. The building with wooden envelope has the lowest temperature but has the highest amplitude of temperature fluctuation valued at 2.3°C. The average temperature is 0.42°C on cloudy day. While on sunny day, the average temperature is even lower (0.28°C). Despite the average temperature of exterior surface is higher than others, the distribution of temperature is uneven. The upper part of the wooden façade adjoining the testing room is shaded by eaves thus has a relatively low temperature. The average interior temperature of building with tiled cement brick walls is the highest (valued at 2.01°C on cloudy day and 2.22°C on sunny day). Even so, the interior air temperatures are far below the thermal comfort range of local residents. According to previous study, the 90% acceptable range in winter is 6.85-13.60°C in operative temperature [5].

Because the influence factors of interior air temperature are more complicated, the relationship between exterior surface temperature and interior air temperature is uncertain. The building with wooden board wall has the lowest indoor temperature while its surface temperature is relatively high. Whereas the glaze ceramic tiles has the lowest surface temperature but the indoor temperature is higher than the others.

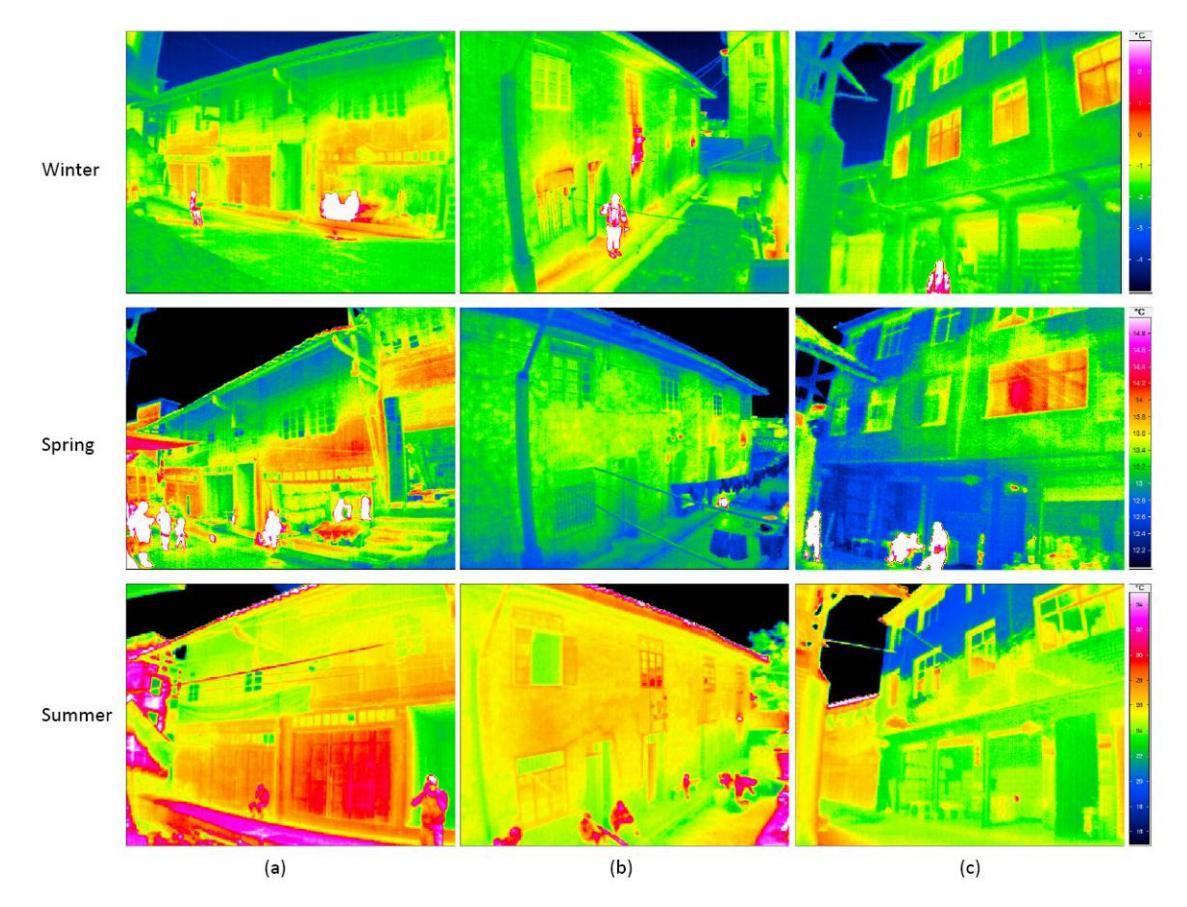
Figure 8 Seasonal differences. (a) is the building with wooden walls; (b) is the building with stone walls; (c) is the building with tiled cement brick walls

The seasonal variation is distinctive, **as shown in Table 2 and Figure8**. The differences between different envelopes are more significant at higher temperatures. In February, the average exterior surface temperature of wooden façade is 0.66°C higher than that of stone wall. In April, the average exterior surface temperature of wooden façade is still the highest, valued at 13.96°C. While the stone façade and the brick façade have the similar temperature valued at 12.99°C and 12.97°C respectively. The temperature gradient is approximately 1°C. In August, the temperature gradient reaches 5.13°C. Wood façade still gets the highest temperature of 27.45°C. And the temperature spans are wider in summer than the other two seasons.

Table 2. Thermographic Records of Different Seasons (10:00 am)							
°C	Avg	Min	Max	Span	SDev		
WINTER (19th February, 2014)							
Wood	-0.23	-1.13	1.81	2.94	0.34		
Stone	-0.89	-1.87	0.94	2.81	0.35		
Tiled Brick	-0.87	-2.24	0.49	2.73	0.74		
SPRING(15th April, 2013)							
Wood	13.96	12.75	14.51	1.75	0.31		
Stone	12.99	12.54	13.75	1.20	0.18		
Tiled Brick	12.97	12.56	13.62	1.07	0.15		
SUMMER(27th August, 2011)							
Wood	27.45	24.17	30.94	6.77	1.86		
Stone	25.34	23.45	27.33	3.88	0.83		
Tiled Brick	22.32	18.81	25.77	6.95	2.44

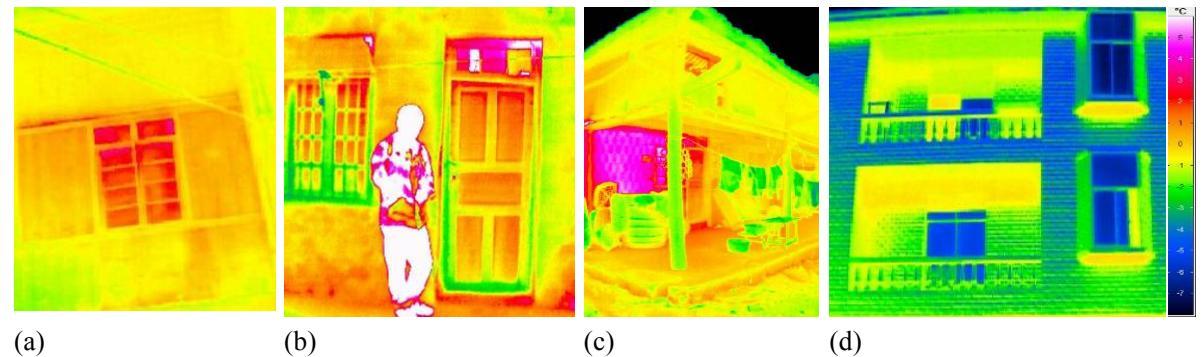
Figure 9 Detailed thermographs of building defects (a) shows the second floor window of a timberwork house; (b) shows the window and door of a stone house; (c) shows the exposed cement brick wall of a timberwork house; (d) shows windows and balconies of a reinforced concrete house

The most common use of IR thermography is for building diagnostics. It can be used to identify air leakage through openings, heat losing areas and moisture problems. To minimize the effect of incident solar radiation, the measurements for detecting building defects were performed at late evening (at 8:00 pm, on February 20th, 2014), **as shown in Figure 9**. Thermographs (a) and (b) show windows or a door frame viewed from exterior. The "red lines" along the top of the openings show the locations for hot air exfiltration. Thermograph (b) also indicates the possible water damages at the foot of the stone wall. The surface temperature is higher in this area, since the heat is conducted through wet mass more rapidly from interior. The red part of the façade in thermograph (c) is exposed cement brick wall with no insulation. (d) is the thermograph of a reinforced concrete building. The brighter parts under the eave and balconies are exposed concrete slab. There's no obvious air leakage around the openings, which may explain the fact that the indoor air temperature is higher than timberwork and stone houses even if the heat gains through the building envelopes are less. These resluts suggest that to improve building performance in this area, some measures should be adopted. Fill up the wall cracks and gaps around openings. The building foundation should be dampproof and waterproof. Thermal insulation mortar or polystyrene board can be used for building exterior walls.
